ATTACHMENT 2: INSPECTION PHOTOGRAPHS

ATTACHMENT 3: CONFIDENTIALITY NOTICE

ATTACHMENT 4: FIELD SAMPLING RESULTS

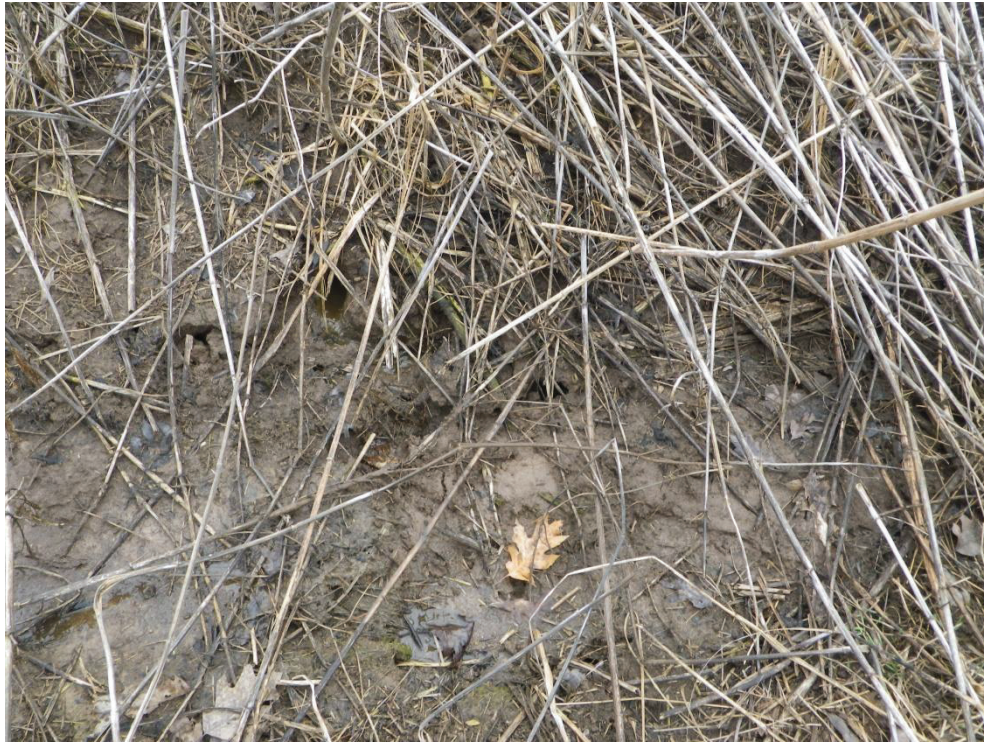
63: IMGP0316.JPG

Description: Portion of pathway on the north end of the field north of the Milk Cow Barn leading to unnamed tributary.

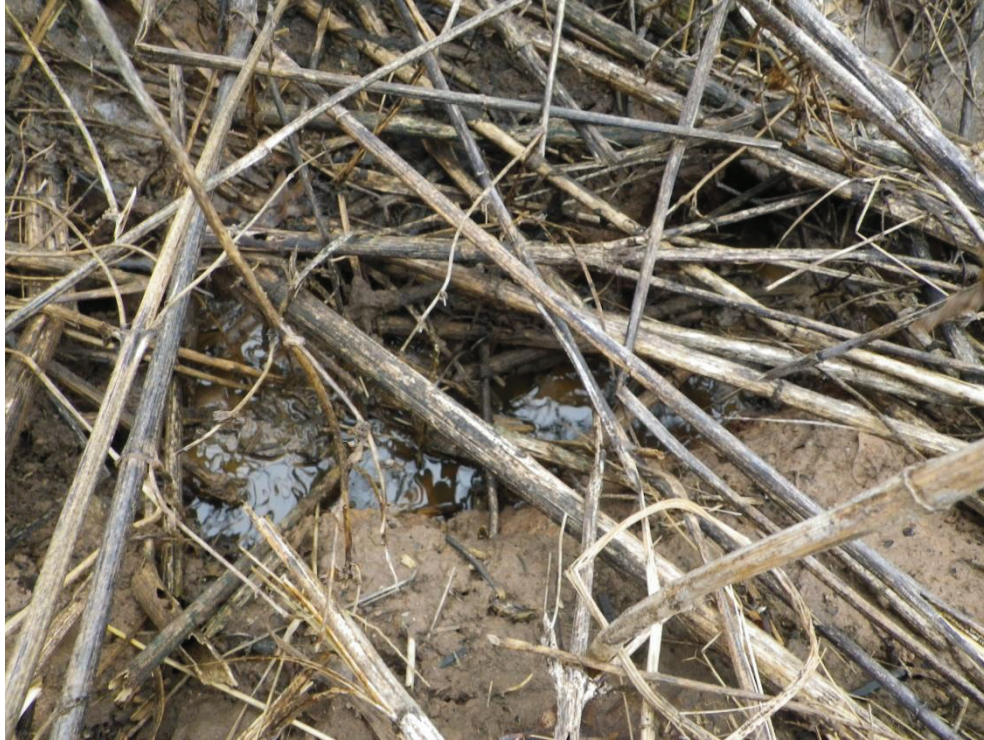
64: IMGP0317.JPG

Description: Portion of pathway on the north end of the field north of the Milk Cow Barn leading to unnamed tributary.

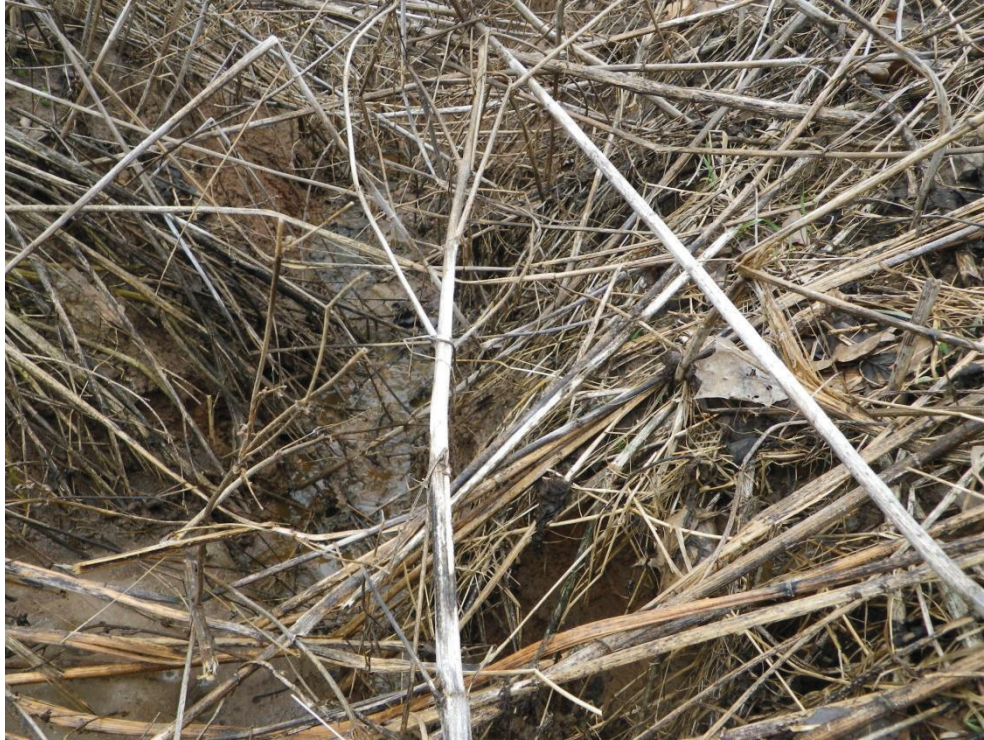
65: IMGP0318.JPG

Description: Portion of pathway on the north end of the field north of the Milk Cow Barn leading to unnamed tributary.

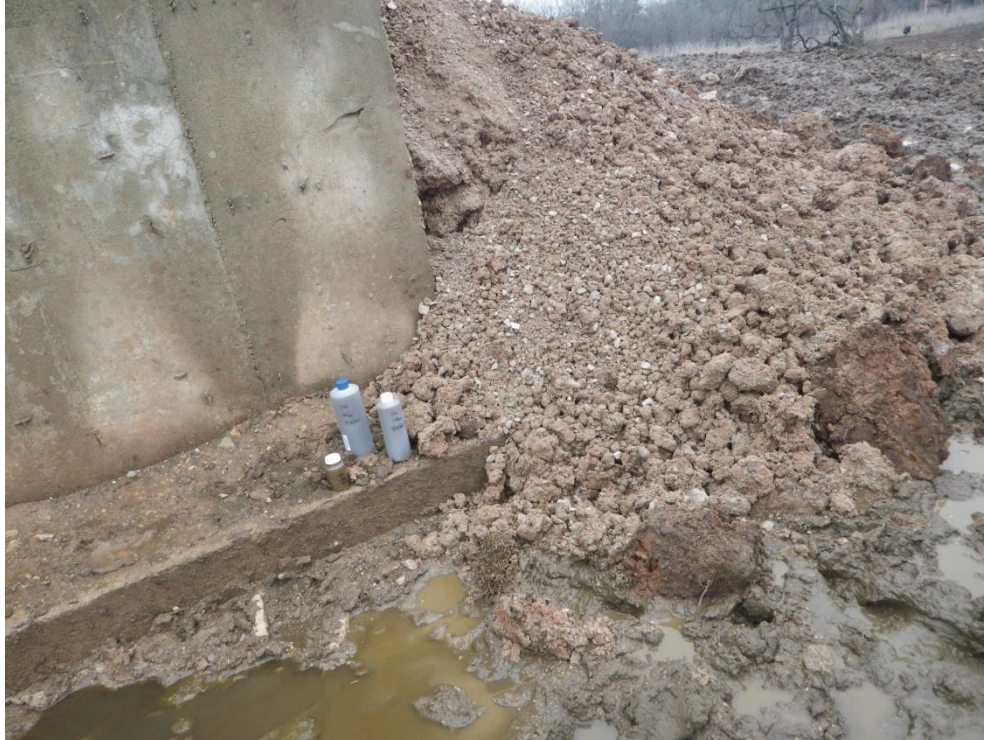
67: IMGP0320.JPG

Description: Sample S06, wastewater from hole in the concrete manure pit. During the inspection the facility owner placed a pile of fill over the hole in the concrete pit.

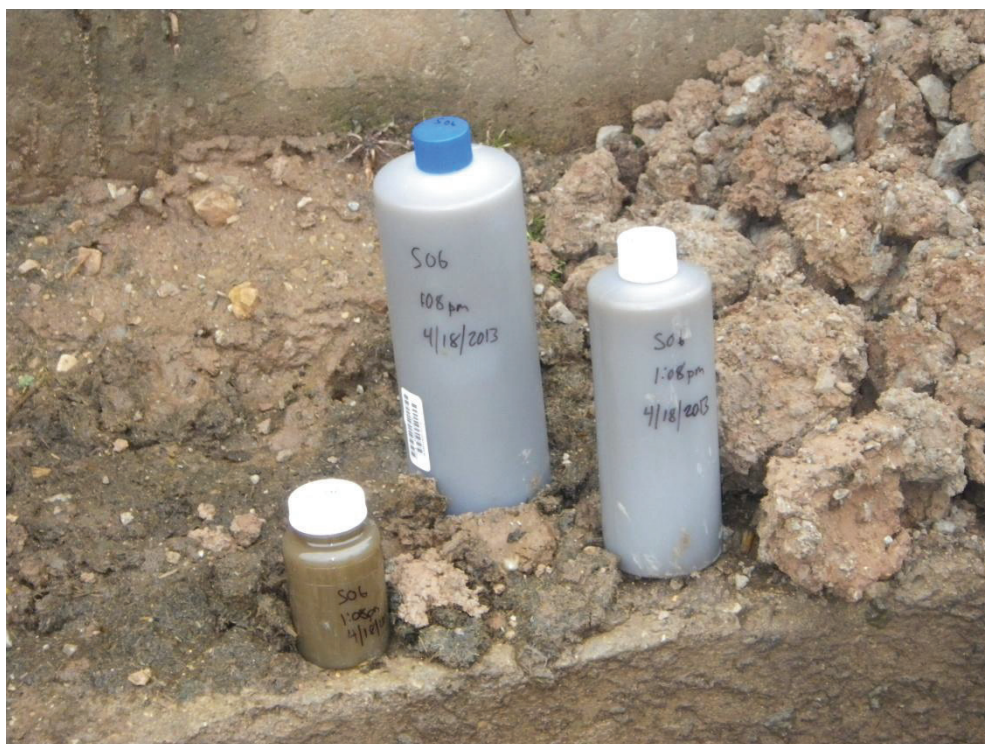
68: IMGP0321.JPG

Description: Sample S06, wastewater from hole in the concrete pit.

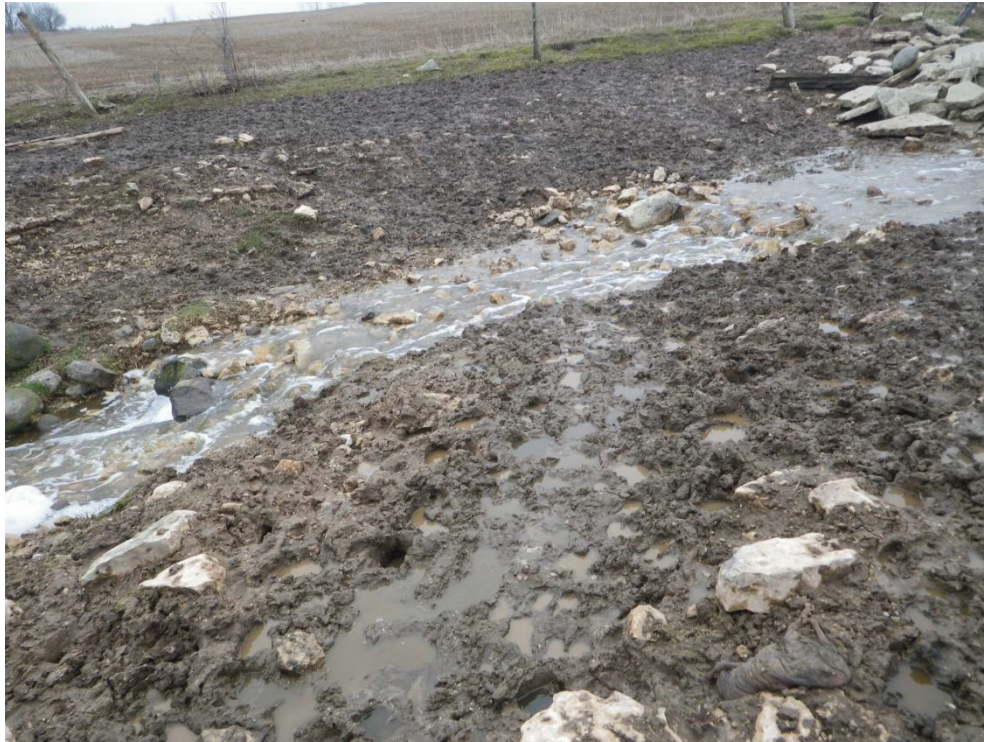
69: IMGP0322.JPG

Description: Flow pathway from drainage of the concrete pit to the unnamed tributary.

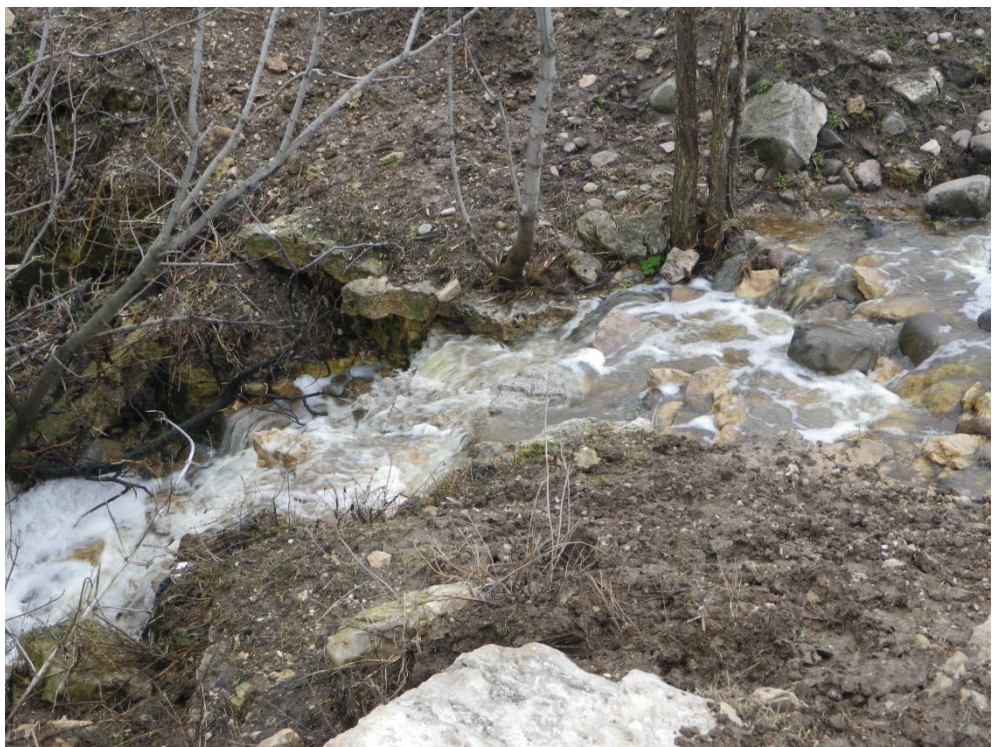
70: IMGP0323.JPG

Description: Cattle had direct access to unnamed tributary which flows north through the east side of the production area.

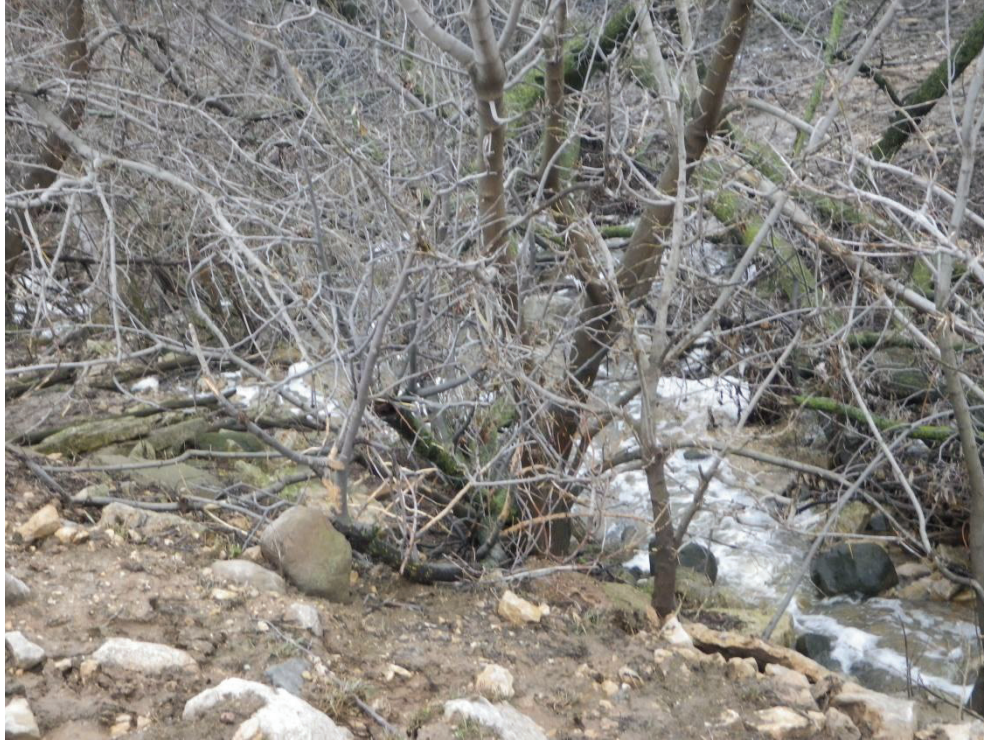
71: IMGP0324.JPG

Description: Cattle had direct access to unnamed tributary which flows north through the east side of the production area.

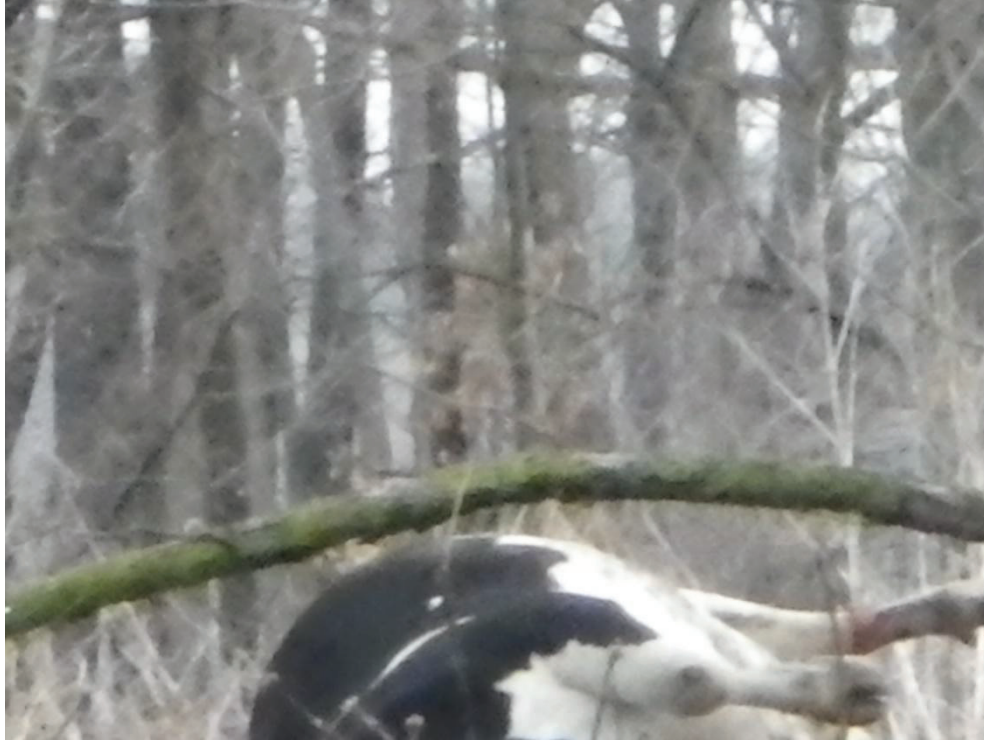
72: IMGP0325.JPG

Description: Dead cow in the open lot.

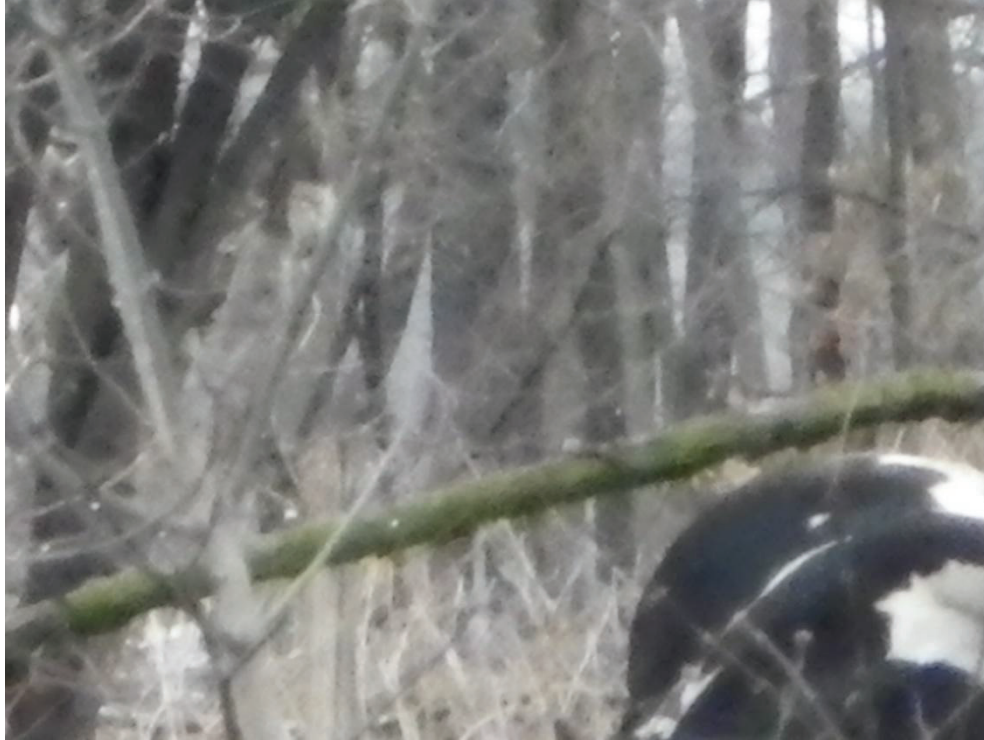
73: IMGP0326.JPG

Description: Dead cow in the open lot.

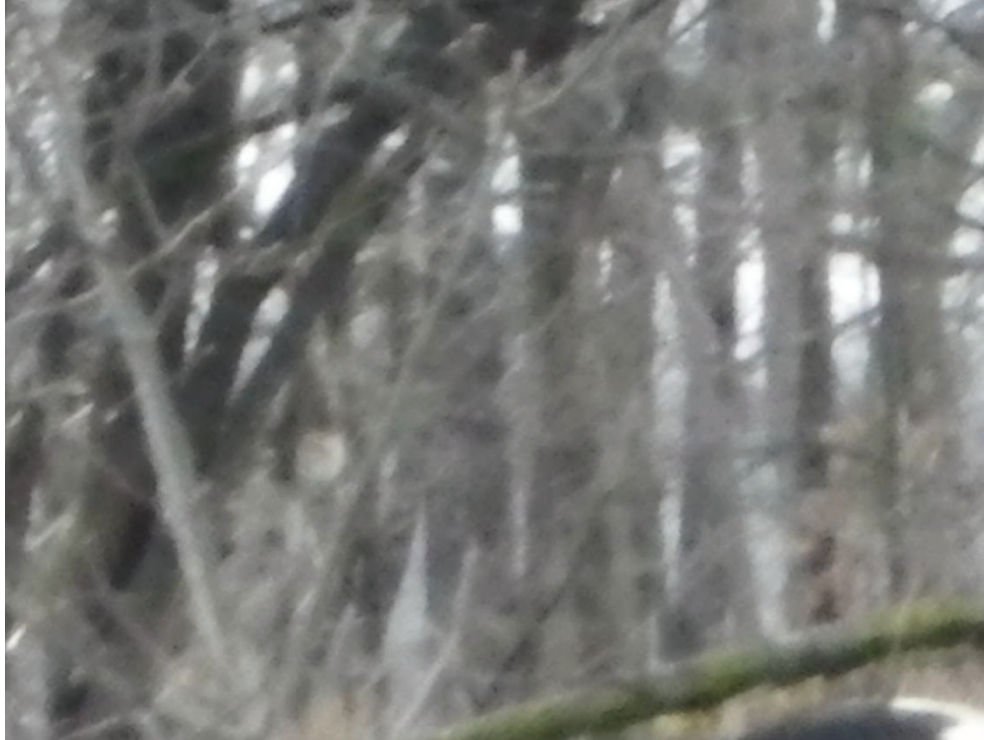
74: IMGP0327.JPG

Description: Dead cow in the open lot.

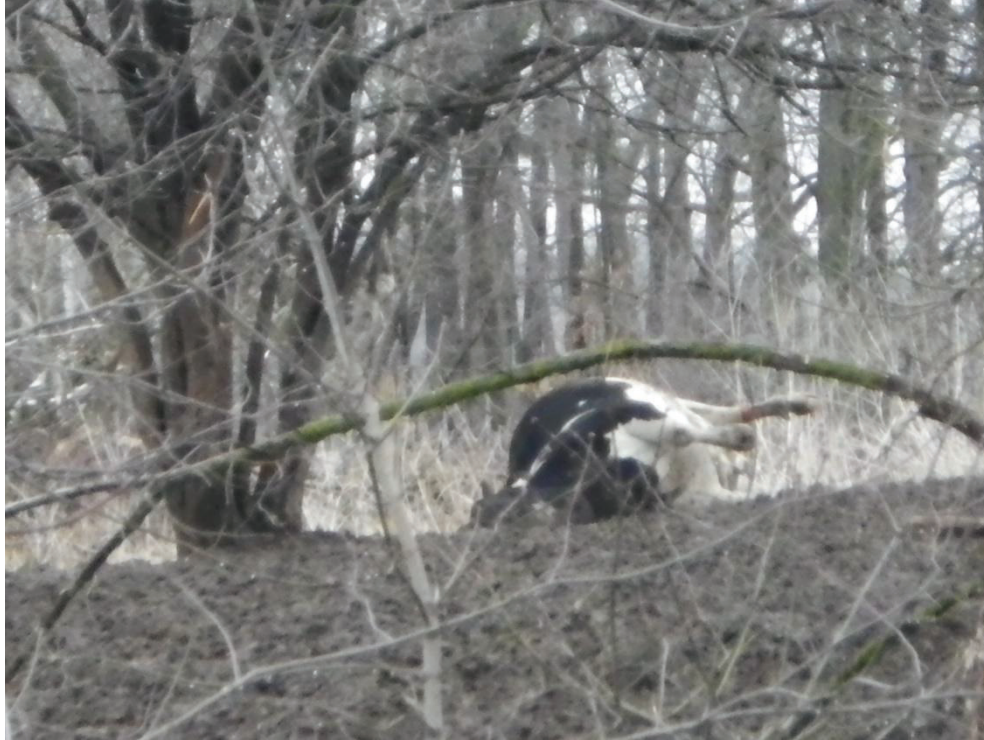
75: IMGP0328.JPG

Description: Dead cow in the open lot.

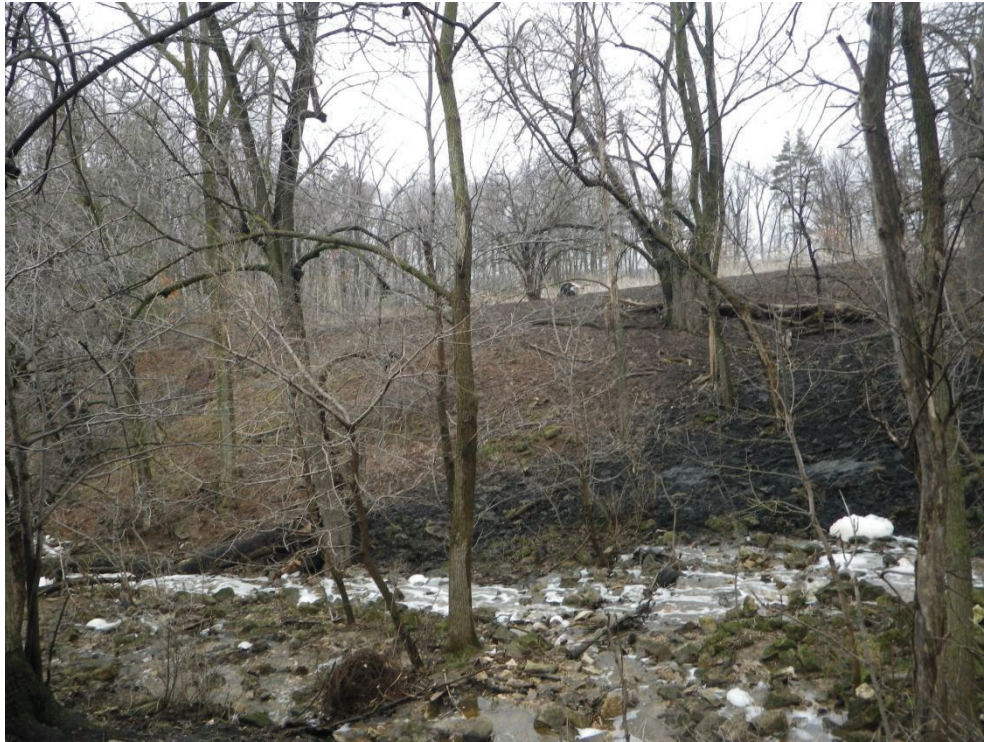
76: IMGP0329.JPG

Description: Cattle had direct access to unnamed tributary which flows north through the east side of the production area.

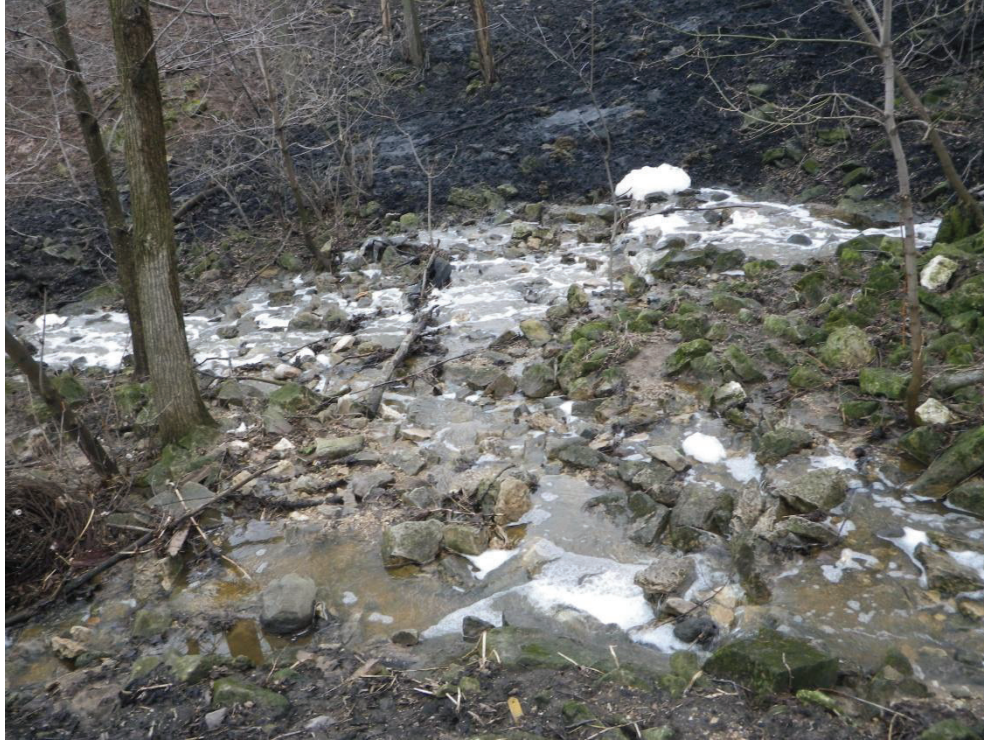
77: IMGP0330.JPG

Description: Cattle had direct access to unnamed tributary which flows north through the east side of the production area.

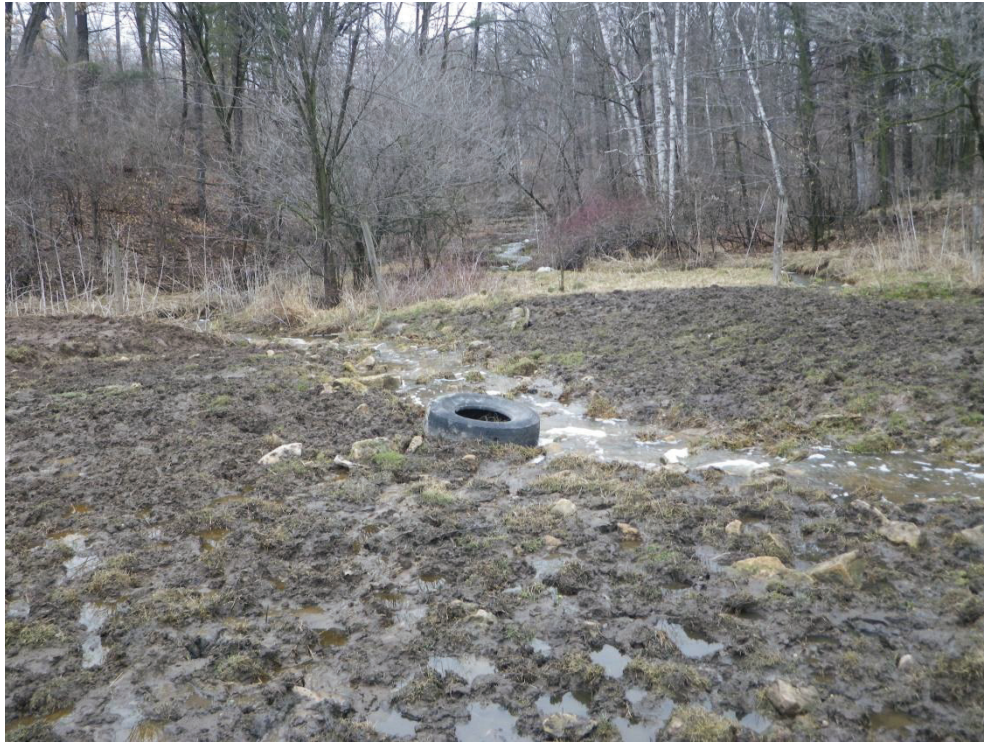
78: IMG0331.JPG

Description: Cattle had direct access to unnamed tributary which flows north through the east side of the production area
